268 Liverpool Road, Islington, London N1 7TD

**CBHA HOUSING GROUP**

January 17, 2017

# 268 Liverpool Road, Islington, London N1 7TD

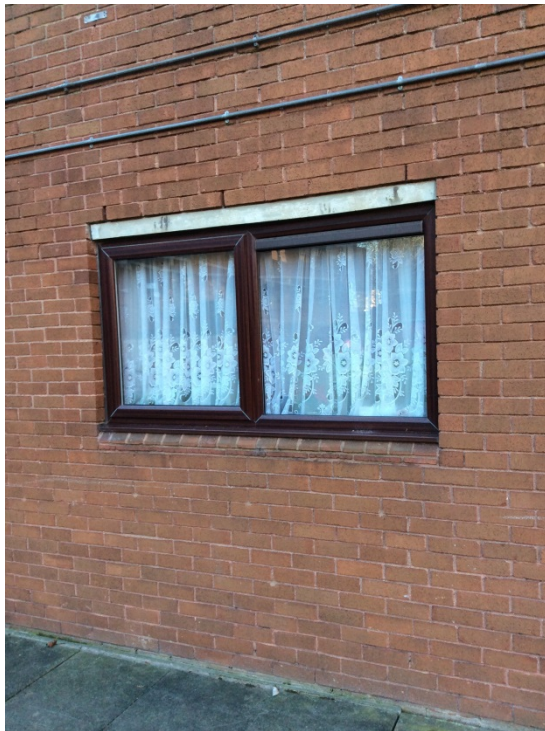
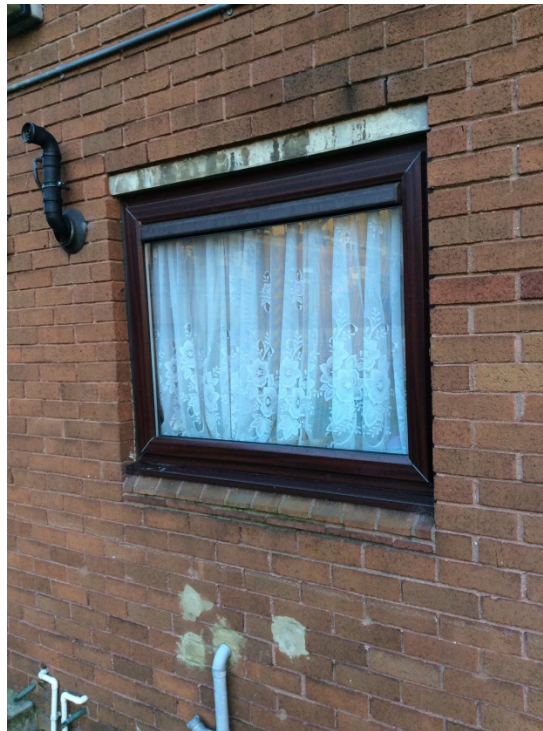
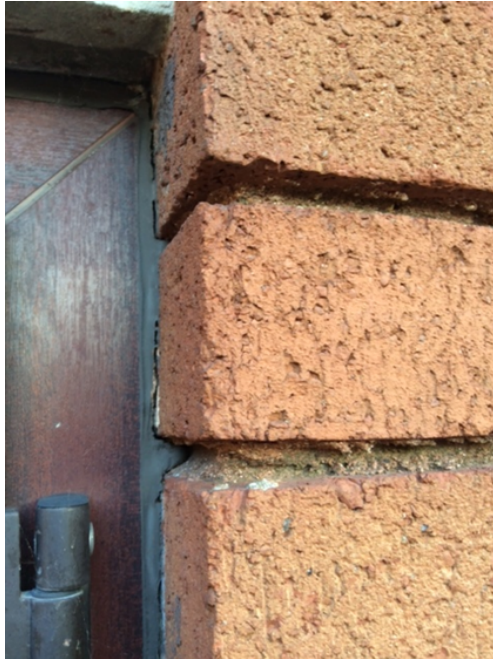
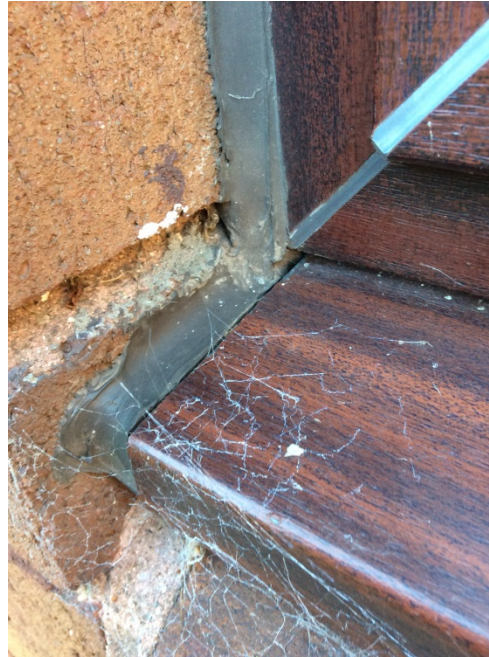
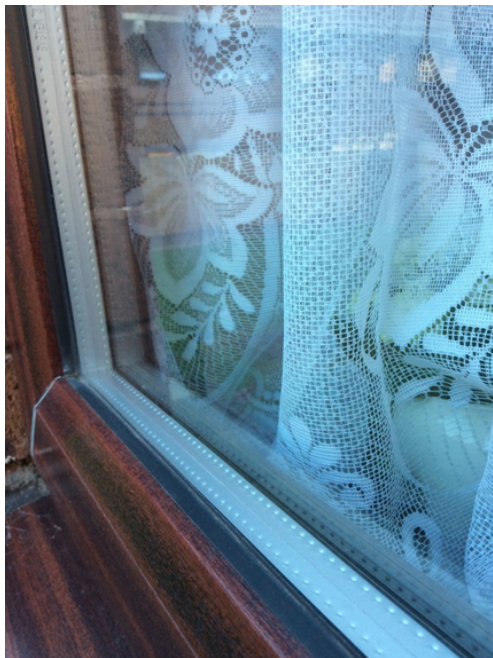
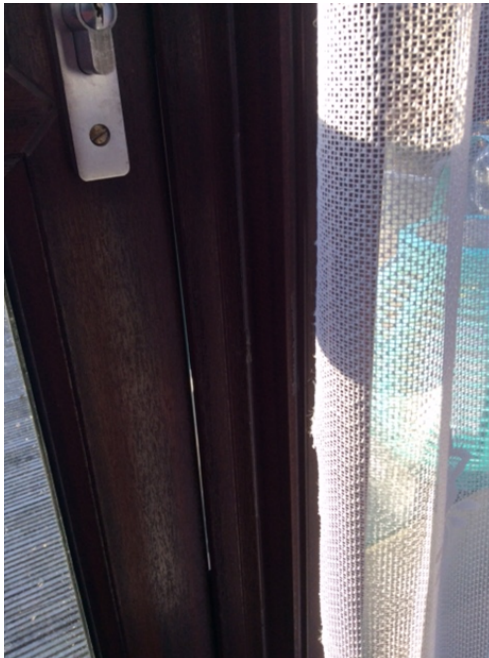
It is clear to see at various intervals the mastic sealant has perished to the extent the seal being compromised.

It is also evident there is gap visible of the rear door, approximately 5 – 10 mm running along the locking style and jamb of the frame.

The locking system of the door is non functional and poses a security risk.

To rate the overall condition of these windows on a scale of 0 –10 (0 being at the base end of the scale) it would be in my opinion a score of 5 – 6.

1. Commission an asbestos survey to test the existing mastic sealant for traces of asbestos content and record as a management action plan.
2. Remove and renew rubber gaskets to all windows throughout the property.
3. To remove existing external sealant and replace with a non solvent based product.
4. Remove and renew rear door.
5. Taking into consideration the age of the doors and windows propose these be considered for a major works replacement program.

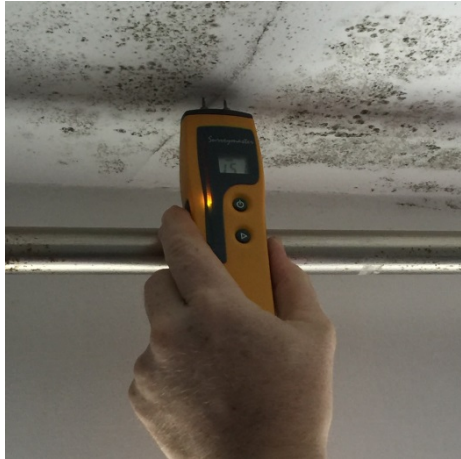
The photograph demonstrates a reading taken at 15% this was consistent throughout the inspected area.

I record Mold commonly known as "*Aspergillus niger*" solely within this room.

- Refer to 3.3 of this report.
- To heat and ventilate the property adequately.
- Monitor by means of installing data loggers to assess the daily activity of the internal environment and provide statistical data.
- Carry out a full service of the gas central heating system.
- To undertake a full chemical clean and removal of the affected areas in accordance with the manufactures guidance.
- Redecorate the affected areas using a suitable anti-fungal treatment
- Occupier education

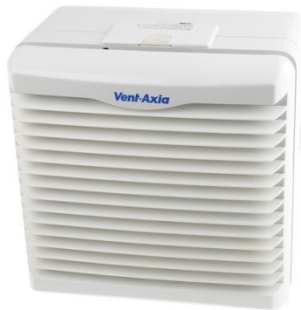
I also record there were two Vent-Axia VA150P extraction fans these were located within the bathroom and kitchen.

Both units were operational and documentation indicates the installation was 2016.

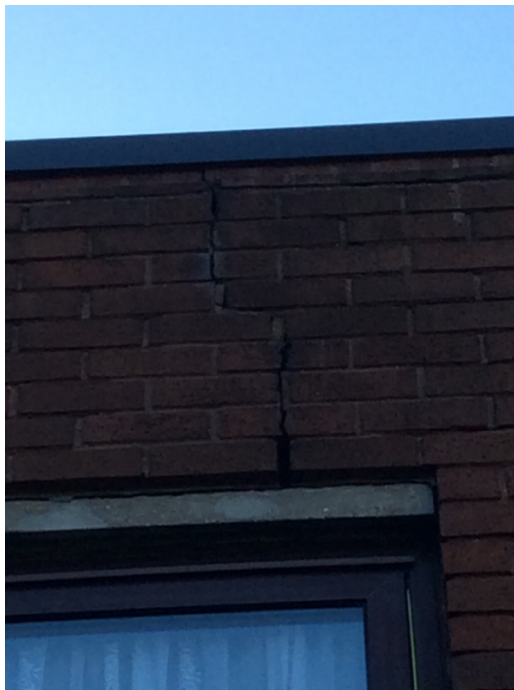
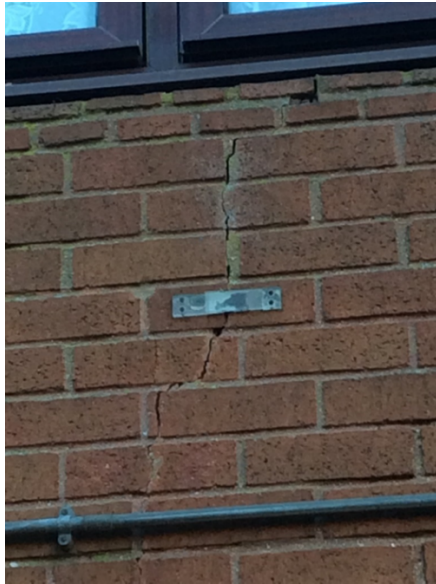
There are two visible cracks, the first located to the right hand side above the double window approximately 750 to 900 mm in length and approxiimatly 10 to 15 mm wide.

The second crack is located just of center, below the same double window approximately 500 to 600 mm in length and approximate width of 5 to 10mm.

The building is set on a pad type concrete foundation base which is subsequently sited on clay, thus being subject to shrinkage and expansion throughout dry and wet seasons.

Currently there is evidence of a crack monitoring device or “tell tale” being used, however there are no documented records to demonstrate if the defect has been appropriately monitored.

- Monitor by means of a crack monitoring device or “tell tale” for a period of 8 weeks to establish the level of movement.
- Prepare a plan of works to be undertaken in accordance with Planning and building control.
- Notify insurance
- Consider temporary or permanent relocation of the current occupier.
- Example of repair work undertaken following movement / cracking to another part of the site indicated by means of the photograph below.

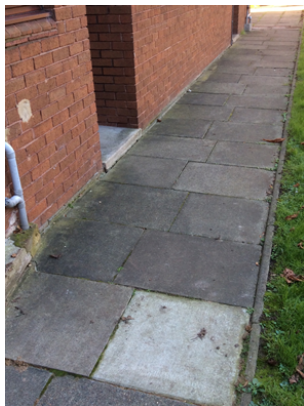
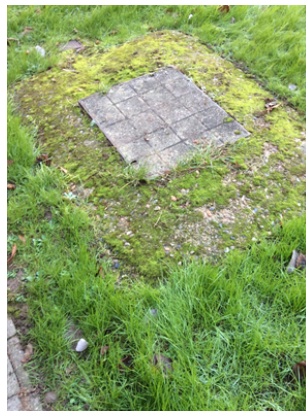
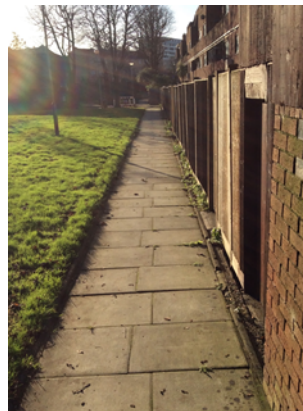
The concrete paving slabs laid in front are uneven. There is evidence of some maintenance has been undertaken.

The access chamber for the drain is just off set to the front door of the property this was inaccessible at the time of my visit.
